Error Types in SDRAMs

M. Shoga
The Radiation Group, Inc.
8/5/2008

This paper describes single event effects (SEE) error types observed testing SDRAMs. Visual maps of these error types are shown in this paper. Such error maps enhances the understanding and thus handling the error types in the system. Better event rates can be calculated from understanding the errors observed in a memory map. Some of these error types cannot be protected with simple error detection and correction (EDAC) codes and requires sophisticated schemes.

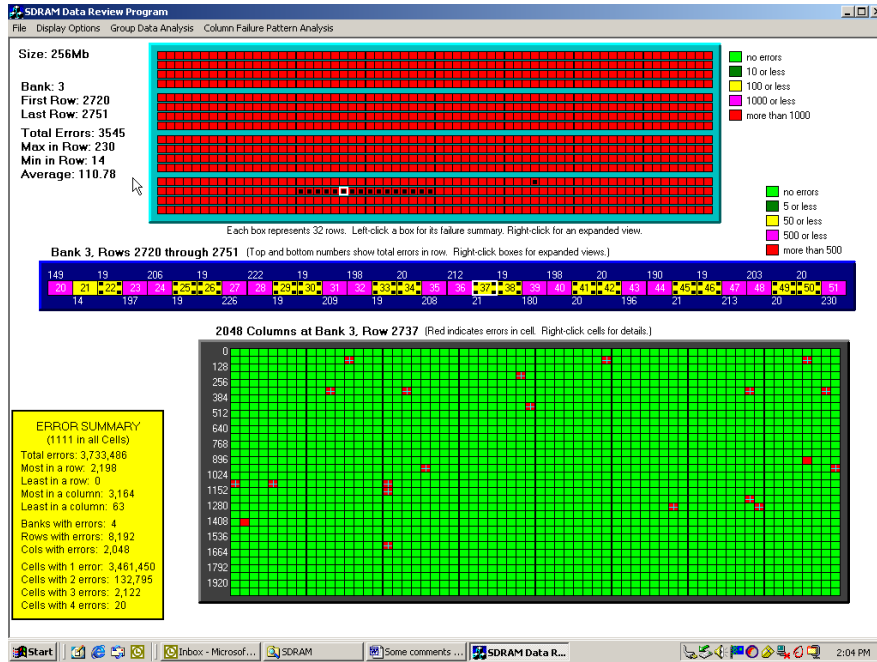
Figure 2. Arbitrary 21-column errors repeated in 20 rows

This is the result of a hit to a gate or a register in the control logic circuitry. Figure 2 shows an arbitrary pattern of 21 errors (marked red in the lower section). The search for this pattern identified a repeated occurrence of many times. Figure 2, top

section, red color with black dots in Bank 0, shows all the locations of this type of error (bottom map).
